**BINGLEY ROAD, MENSTON.
EXISTING DRAINAGE ROUTES.**

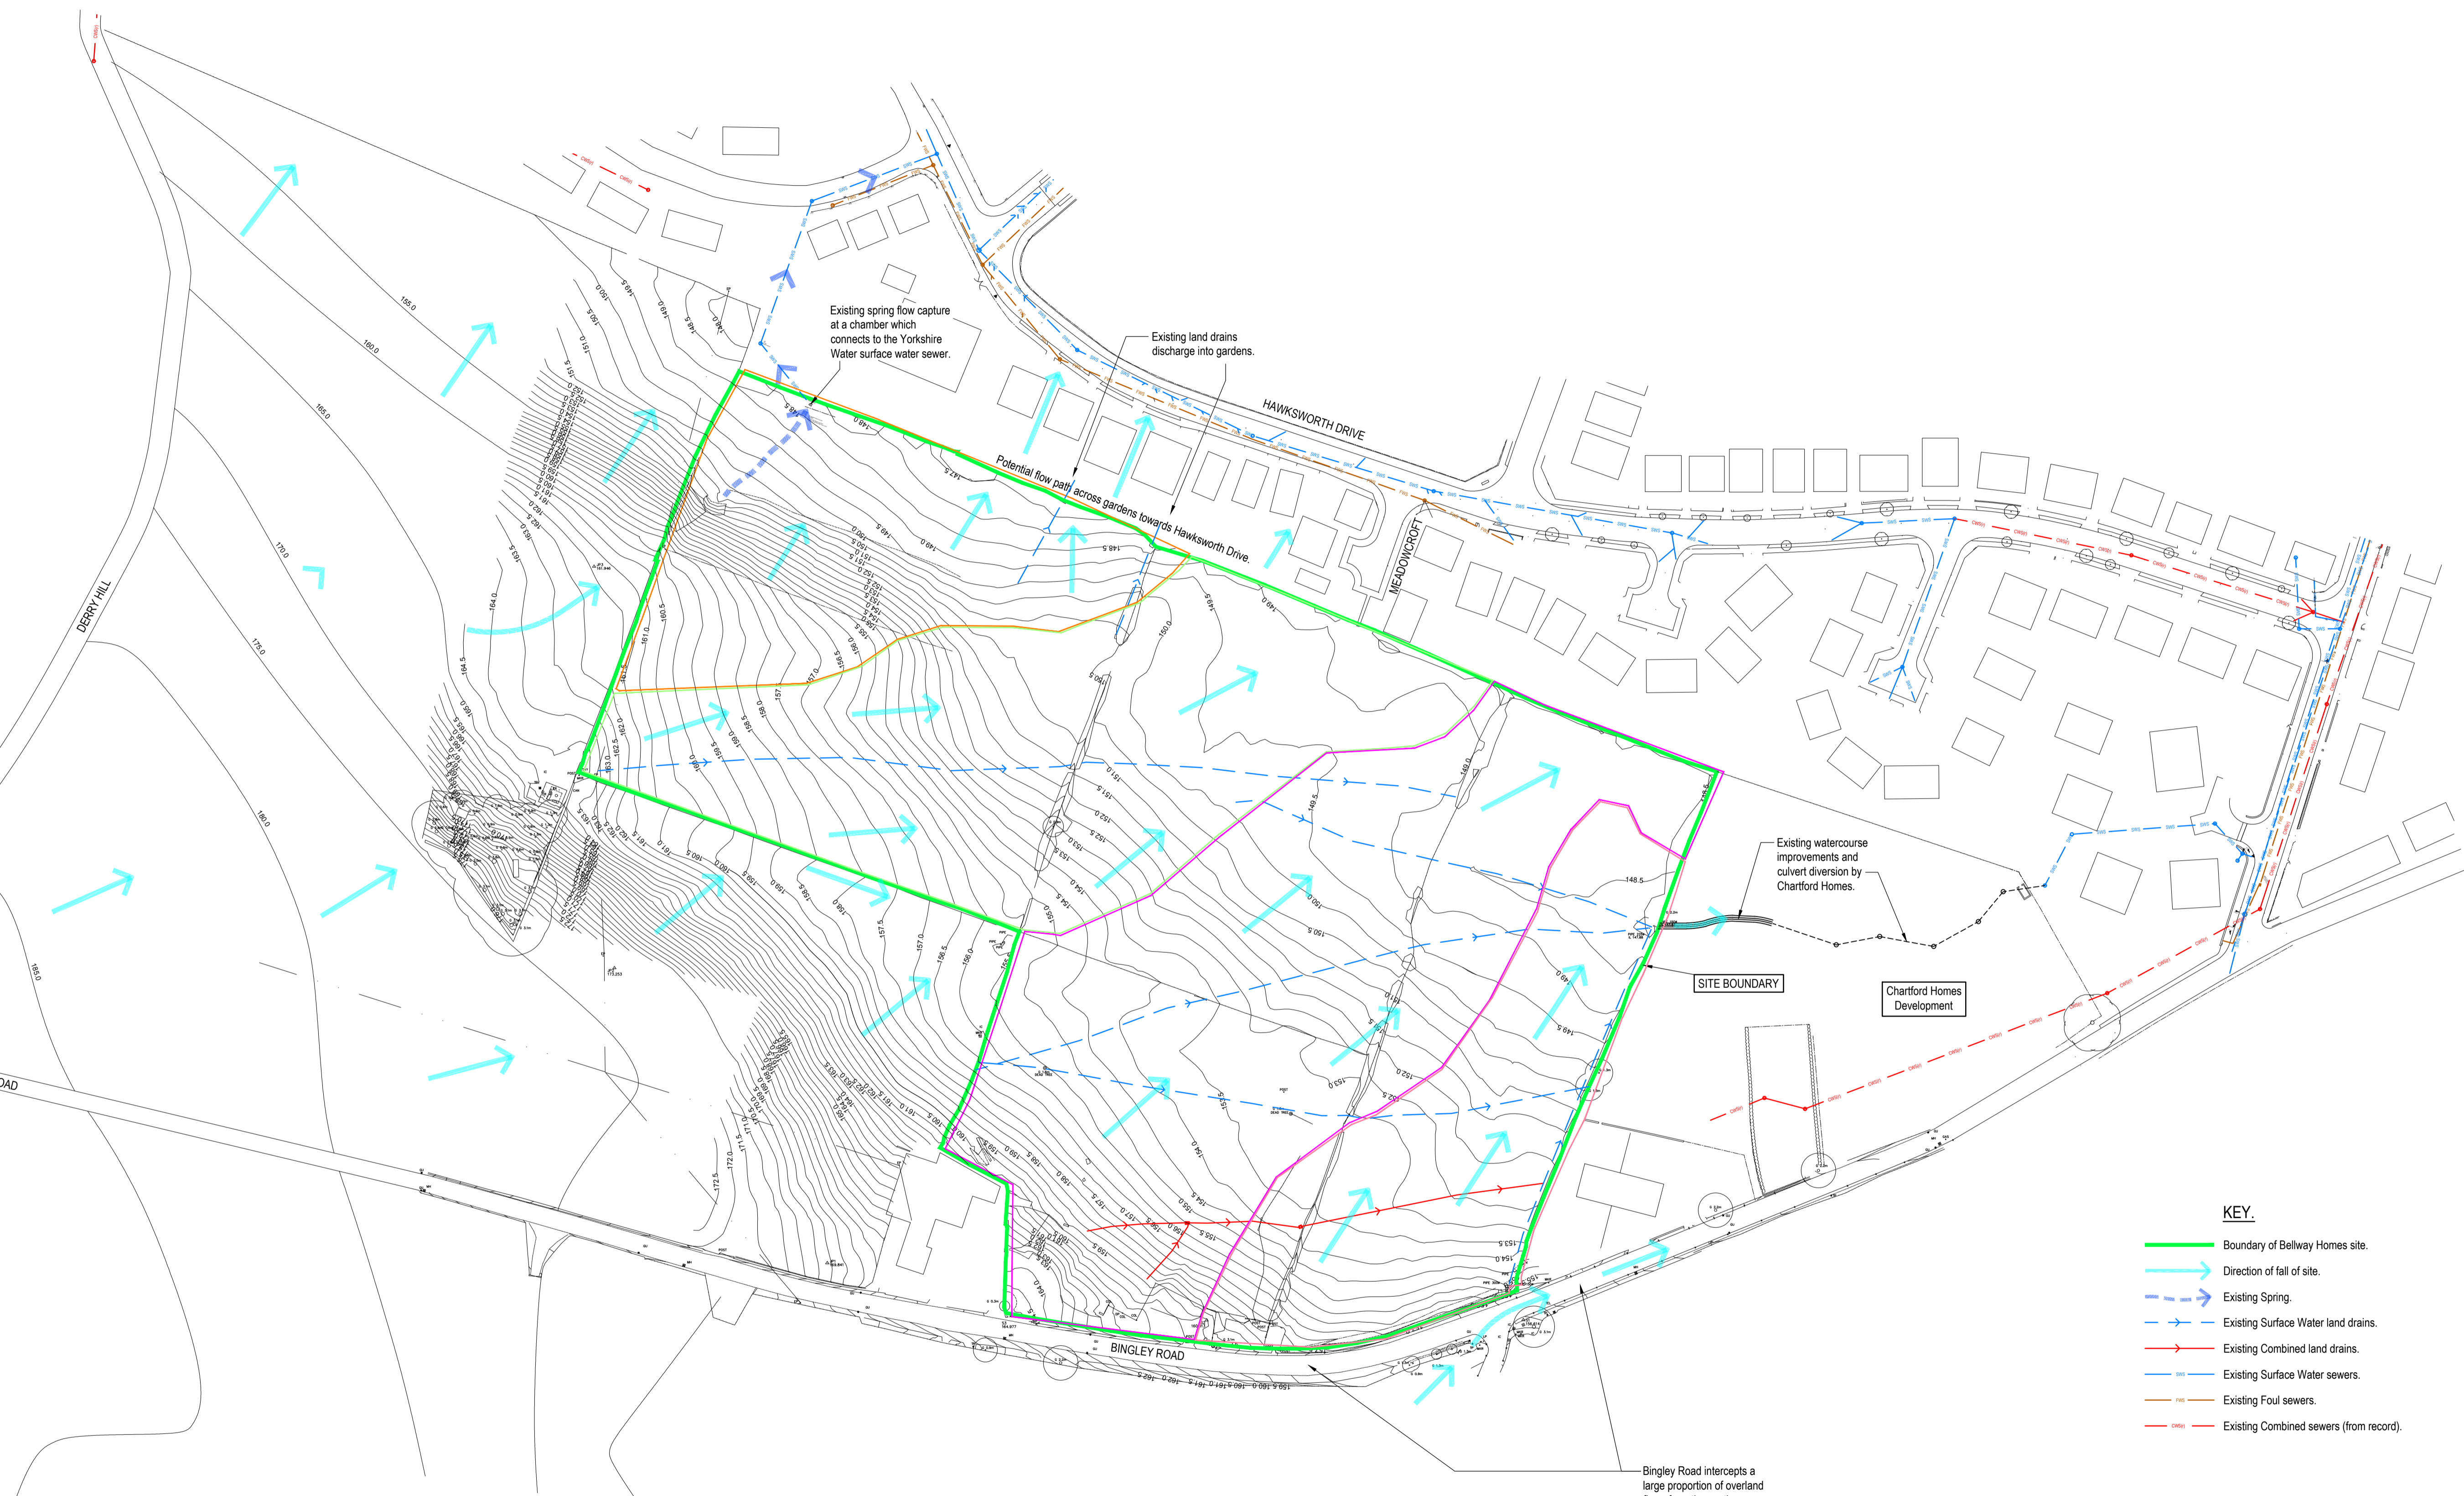
- KEY.**
- Boundary of Bellway Homes site.
 - Direction of fall of site.
 - - - Existing Spring.
 - Existing Surface Water land drains.
 - Existing Combined land drains.
 - Existing Surface Water sewers.
 - Existing Foul sewers.
 - - - Existing Combined sewers (from record).
